NASA
Reference
Publication
1161

Evaluation of Multilayer
Printed Wiring Boards by
Metallographic Techniques

*An Illustrated Guide to the
Preparation and Inspection
of Plated-Through Hole
Test Coupons Based on the
Requirements of MIL-P-55110D*

*Goddard Space Flight Center
Greenbelt, Maryland*

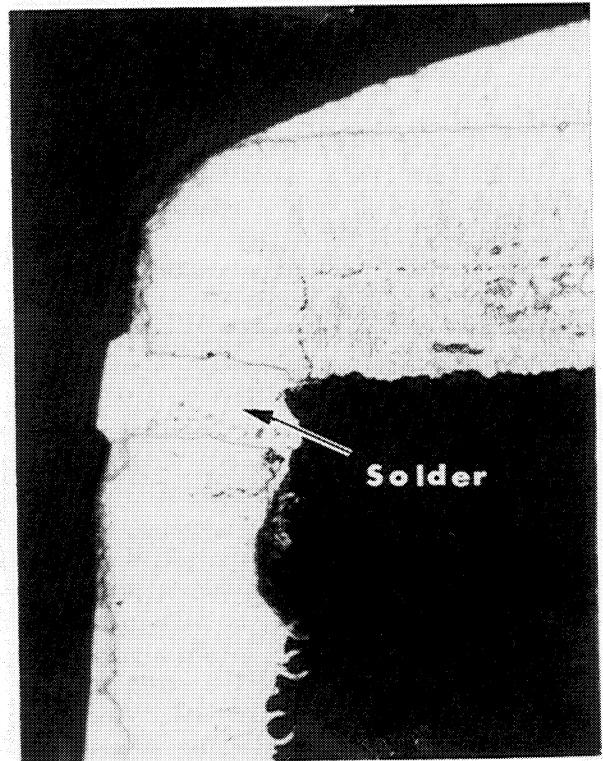
Figure 4a shows a crack in the barrel plating at the high stress area at the surface of the board. Plating cracks commonly result from brittle hole plating, and frequently propagate around the entire circumference of the hole. Cracks tend to form and propagate most readily at grain boundaries, and plating with a large-grained, columnar microstructure such as that illustrated in Figure 4a is much more prone to cracking than is that which is fine-grained and equi-axed. Moreover, the grain boundaries of columnar type plating are aligned perpendicular to the direction of maximum stress, which is that imposed by the increase in the board thickness caused by the large coefficient of thermal expansion of the epoxy in the laminate. In the plane of the board, the epoxy is restrained by the sheets of fiberglass cloth; in the thickness direction no such restraint

exists. The crack in Figure 4a has been bridged by solder during the reflow operation, and electrical continuity testing would not reveal this defect. However, such a hole will have increased electrical resistance, which could be detrimental in high current or low resistance applications. A plated-through hole showing any crack should be rejected. Examination for cracks should be done both before and after etching. Figure 4b shows a corner crack in a double sided board which extends most of the way through the barrel plating. This crack is very tight and was not visible before the specimen was etched. The board which this coupon represents should also be rejected even though the crack does not completely penetrate the plating. Subsequent thermal stress either from rework or from thermal cycling during service could well cause propagation to failure.

- A. CRACK IN BARREL PLATING
ASSOCIATED WITH COLUMNAR
MICROSTRUCTURE. CRACK IS
FILLED WITH SOLDER WHICH
FLOWED IN DURING REFLOW.
MAGNIFICATION 500X.**

REJECT.

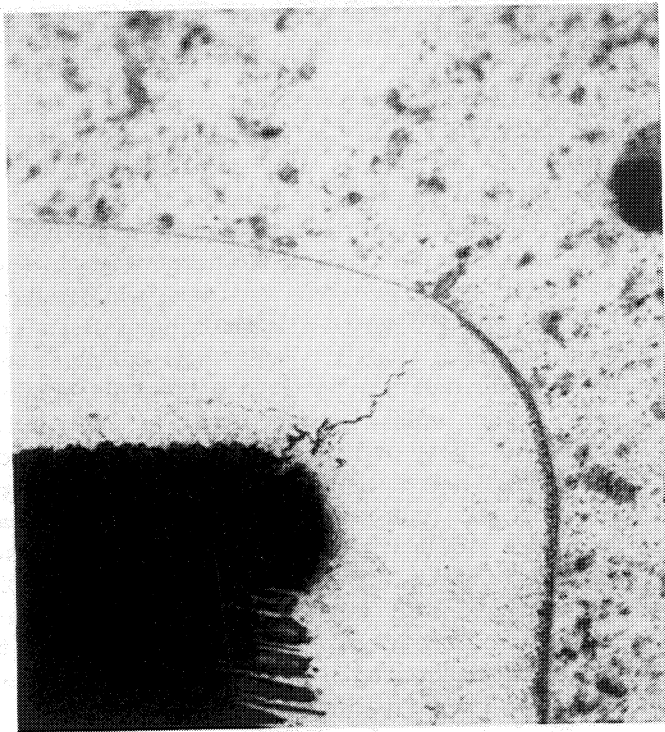
- B. TIGHT CORNER CRACK WAS
NOT VISIBLE BEFORE SPECIMEN
WAS ETCHED. CRACK FORMED
DURING SOLDER FLOAT TESTING.
MAGNIFICATION 400X.**

REJECT.

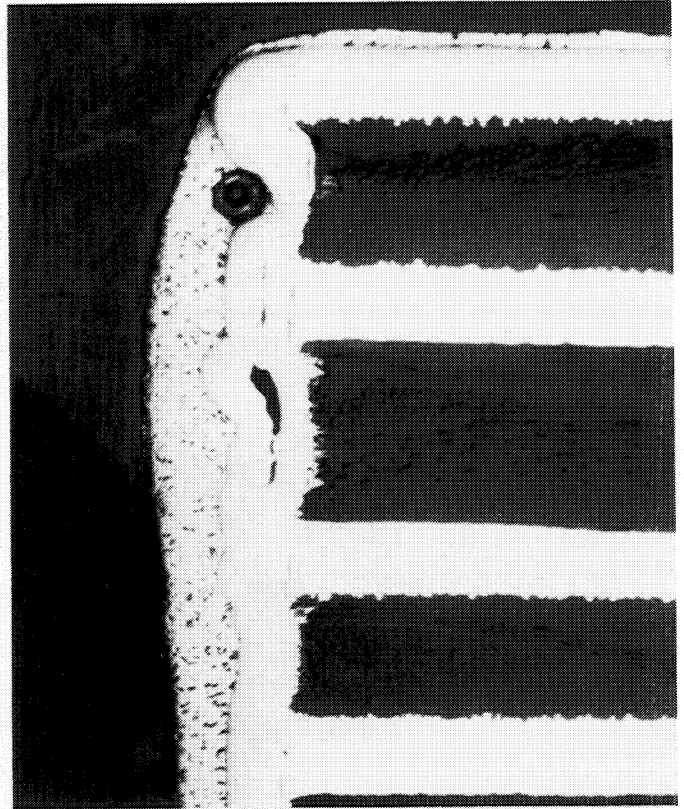
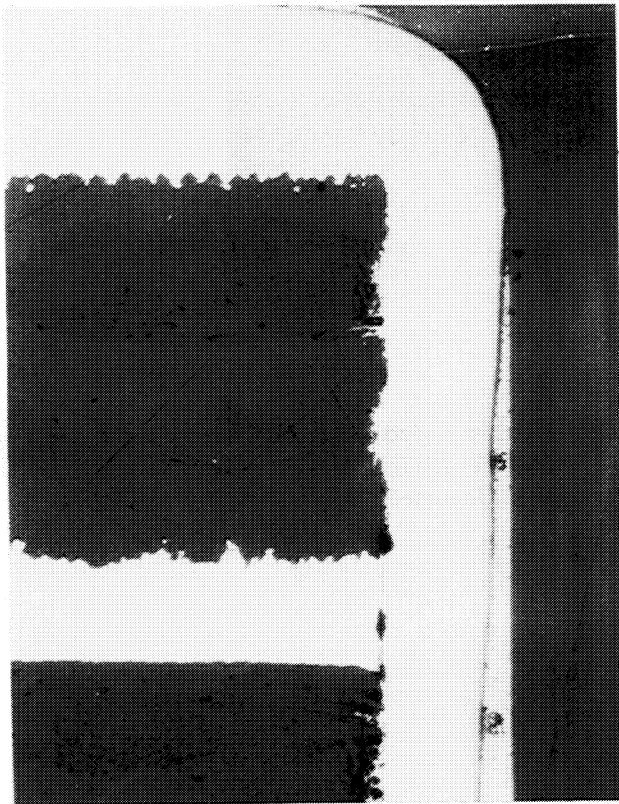
Figure 5. No separations are allowed at conductor interfaces.

Separations may occur between successive layers of barrel plating, Figure 5a, or at the ends of the copper foil layers where the barrel plating bonds to them, Figure 5b. Separations at this latter location are frequently associated with resin smear. Resin smear is exactly what it sounds like: the heat and pressure associated with the drilling operation cause epoxy from the laminate to be dragged over and stuck to the exposed edges of the copper foil of the innerplanes. Unless thoroughly removed in pre-plating cleaning or by etchback (3.8.5, see below), this will prevent good adhesion of the barrel plating to the ends of the innerplanes.

- B. SEPARATIONS BETWEEN HOLE
PLATING AND INTERNAL COPPER
CONDUCTORS (INNERPLANES).
UNETCHED.**

REJECT.

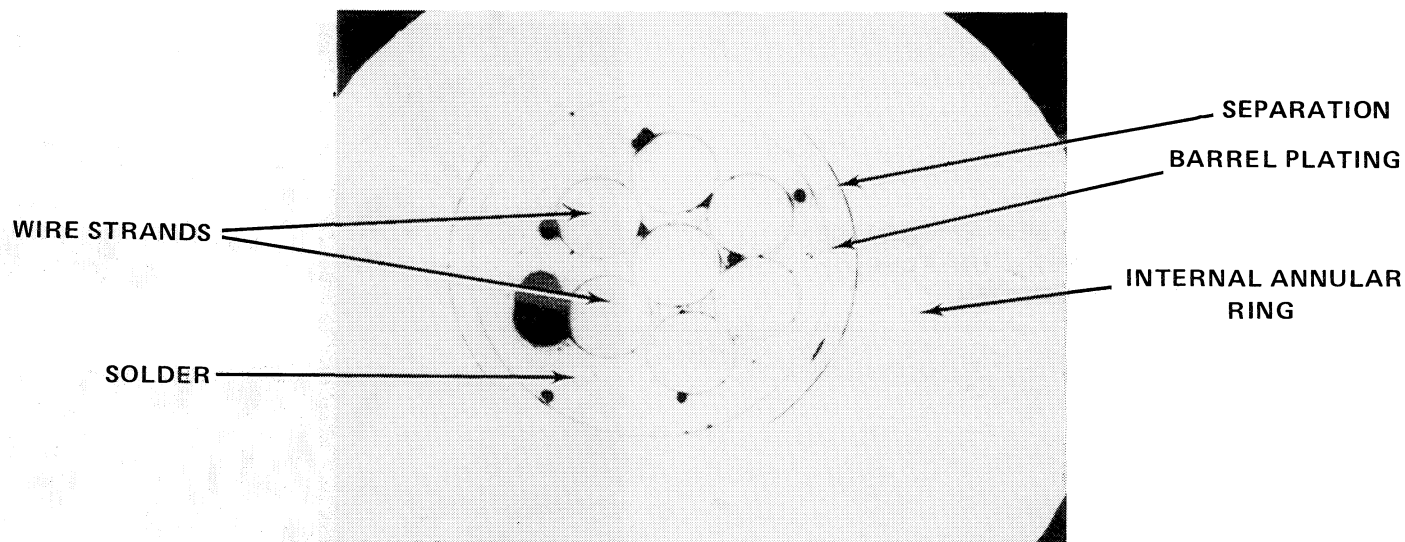
In addition to viewing with increased magnification, the specification calls for a second microsection to be prepared if resin smear is detected or suspected, this time in the horizontal plane (plane of the board), which will reveal the conditions around the circumference of the hole at the foil/plating interface. Figure 6 illustrates two such views.

Figure 6. Transverse sections through plated-through holes with stranded wire soldered into them. Separation in upper photograph extends approximately 240 degrees around the hole; that in the lower photo is continuous all around the hole. Both are rejectable. Unetched, 75X.

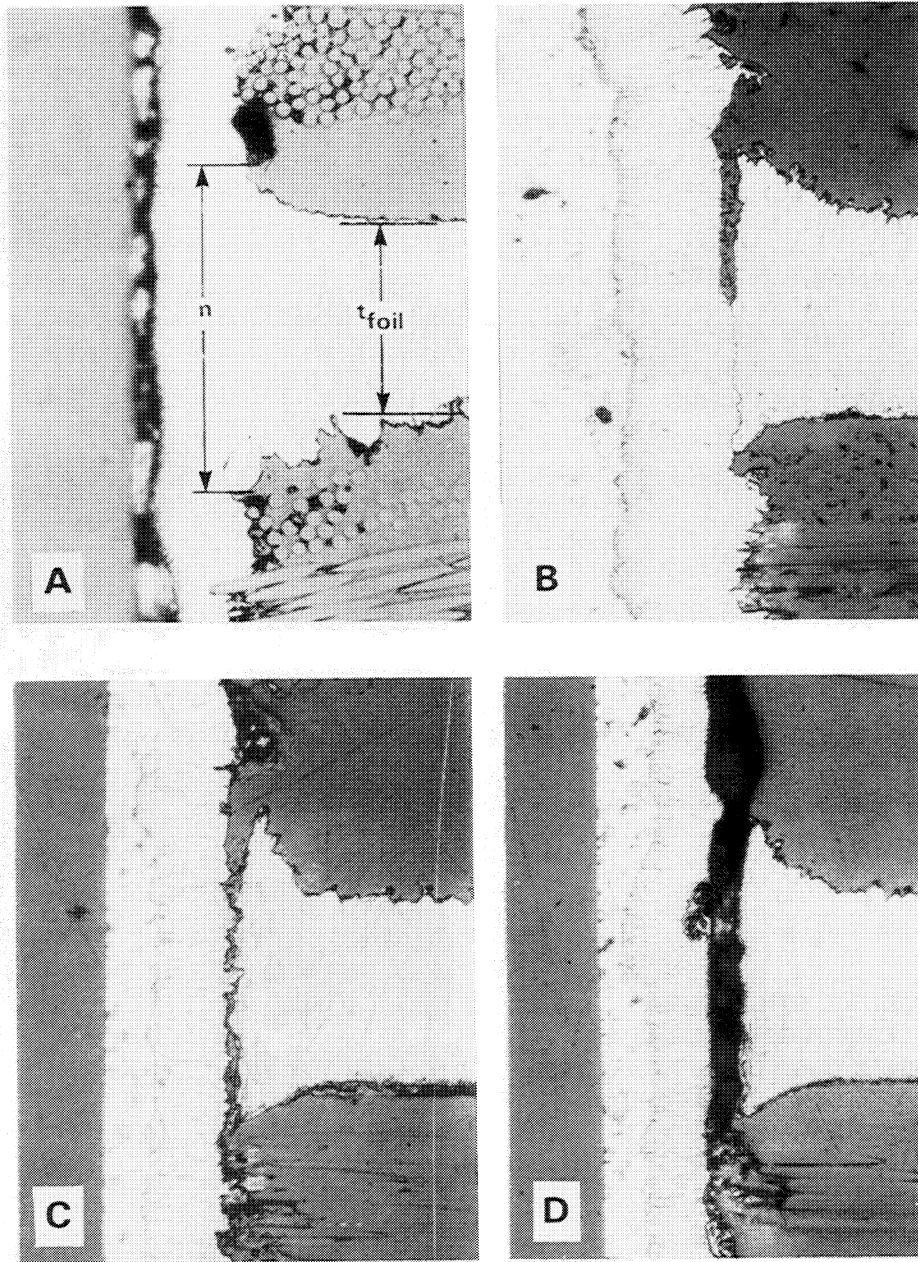
Resin smear is often associated with nailheading. Nailheading (see Figure A-3) is distortion of the ends of the inner foil traces caused by faulty hole drilling techniques such as using dull drill bits, excessive pressure, or improper speed. Poor drilling practice tends to smear excessive amounts of epoxy over the ends of the innerplanes so that the standard hole cleaning or etchback treatments may not remove it all. Nailheading of itself is not harmful and is acceptable provided it does not exceed 1.5 times the foil thickness. Figure 7 gives examples of multilayer plated-through holes with varying degrees of resin smear and separations, all with nailheading of the ends of the innerplanes. The nailheading in Figures 7a and 7c is in excess of that allowed in the specification.

Figure 7. Nailheading is defined as the ratio of the measure of the distorted end of the innerplane to its thickness. Etched, 400X. $N = n/t_{\text{foil}}$

- A. Nailheading (N) with no resin smear or separation. $N = 1.7$, in excess of the 1.5 maximum allowed.
- B. Nailheading with resin smear. $N = 1.6$. May be rejected for both conditions.
- C. Excessive nailheading (1.7) with separation. Reject for both conditions.
- D. Nailheading (1.5) at outer limit of acceptability, but reject for separation.

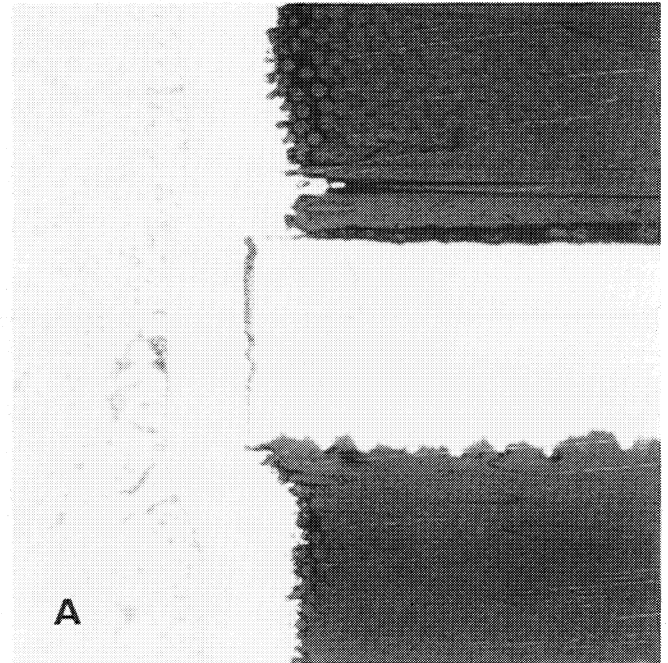
Separations at barrel/innerplane junctions are also often observed which are not associated with any signs of poor drilling practice such as ragged holes, nailheading, or obvious resin smear, see Figure 8. These separations appear to result from a weak bond opening up rather than from no bonding having taken place. This condition was noted in the service failure illustrated in Figure 8b. This hole showed increased resistance after thermal cycling.

- A. SMOOTH HOLE WALL, NO NAILHEADING, SEPARATION AT BARREL/INNERPLANE JUNCTION. PATTERN INDICATES THAT AT ONE TIME THE PLATING WAS JOINED TO THE FOIL END. UNETCHED. 400X.

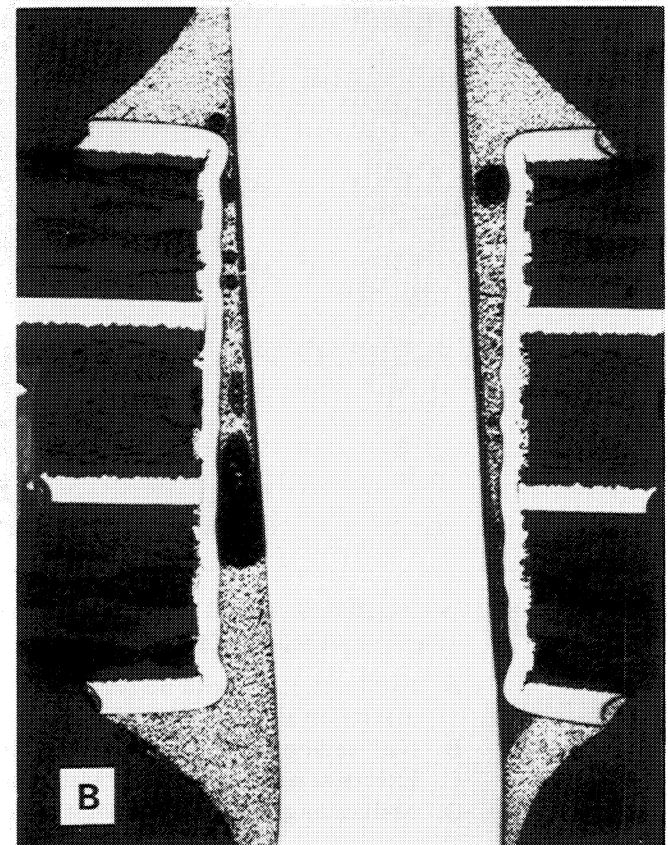
Figure 8. Separations not associated with resin smear or nailheading.

- B. SERVICE FAILURE. THERMALLY CYCLED HOLE WITH RESISTOR LEAD SOLDERED INTO IT, WITH SEPARATIONS AT BARREL/INNERPLANE JUNCTIONS. HIGH RESISTANCE WAS NOTED AT THIS HOLE.

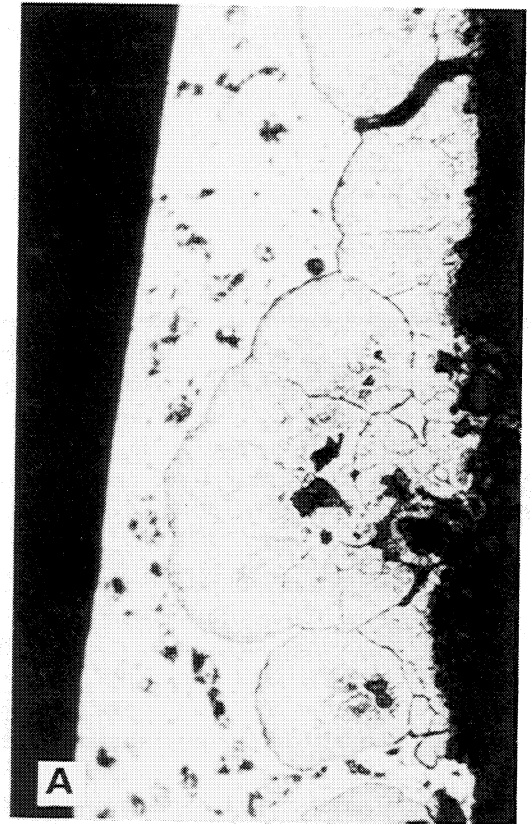
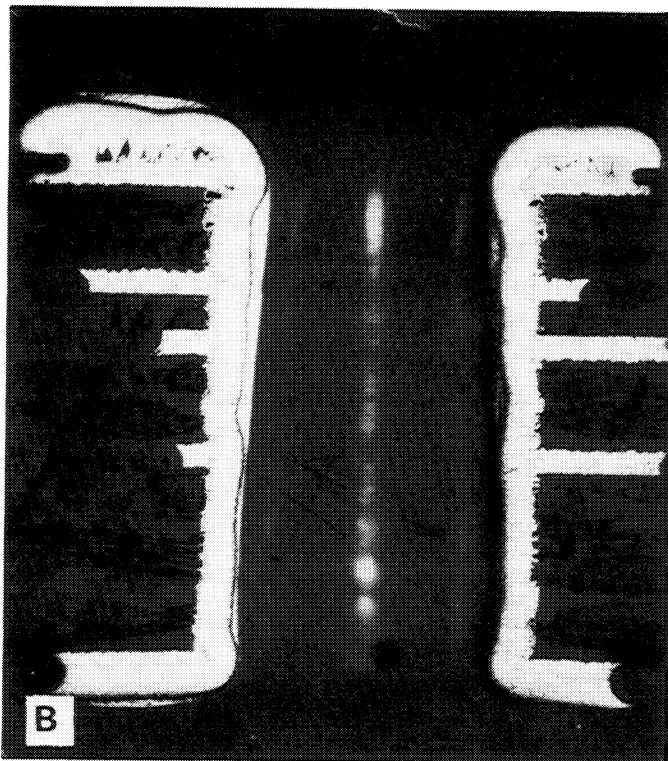
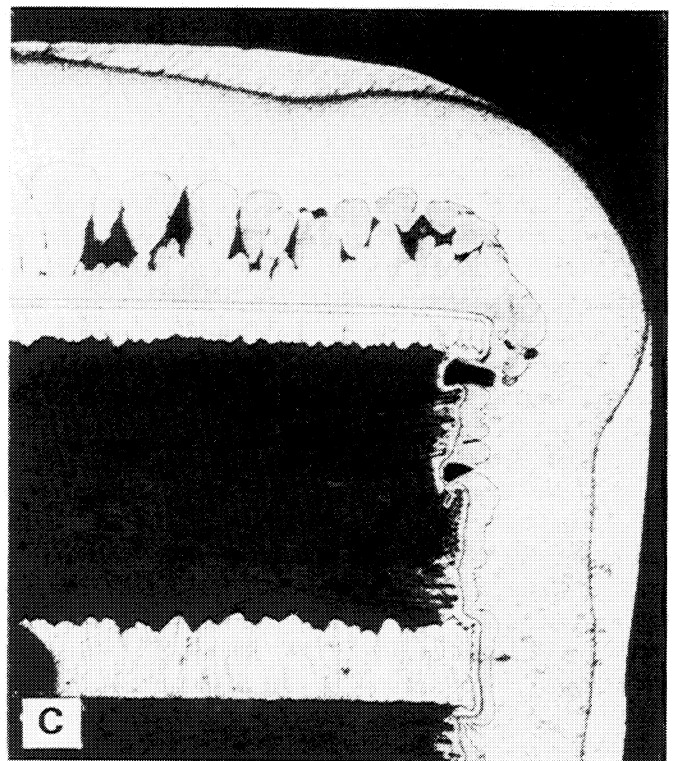
Figure 9. Examples of plating nodules in barrel plating.

- A. NODULES ASSOCIATED WITH BRITTLE PLATING PROBABLY RESULT FROM PLATING BATH COMPOSITION PROBLEMS. THE NODULES WOULD BE ACCEPTABLE; THE CRACKS ARE NOT. ETCHED, 500X.
- B. NODULES IN ONE PLATING LAYER ON ONE SIDE OF THE BOARD MAY RESULT FROM IMPROPER POSITIONING OF ELECTRODES DURING PLATING. ETCHED, 50 X.
- C. HIGHER MAGNIFICATION VIEW OF HOLE ILLUSTRATED IN B. ETCHED, 175 X.

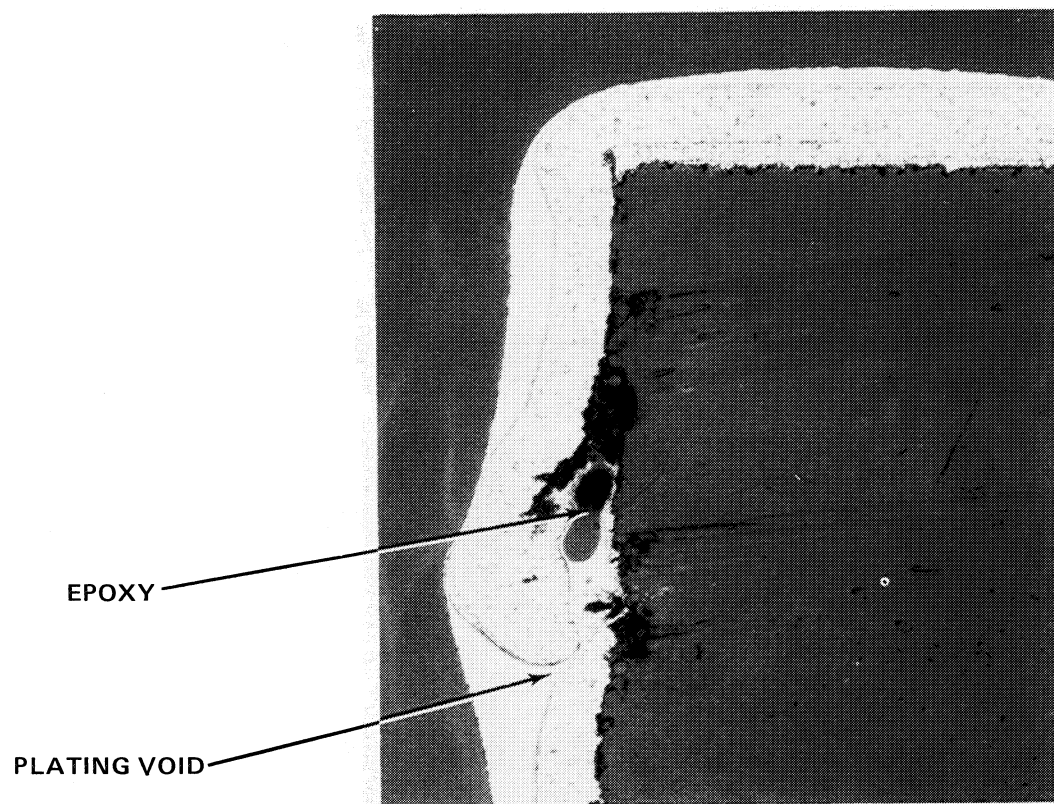
Figure 10. Nodules which formed on rough hole wall have led to a plating void. Etched. Upper photo at 200X; lower at 400X.

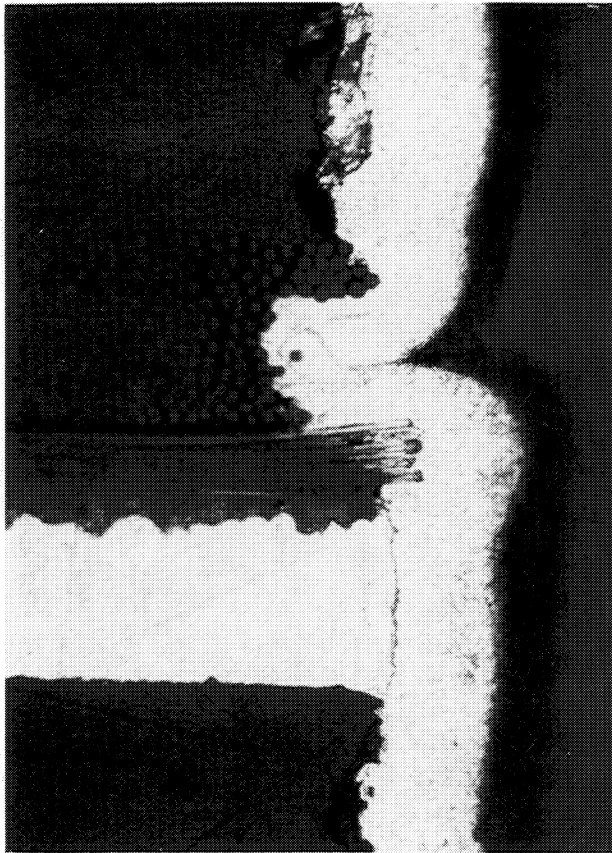
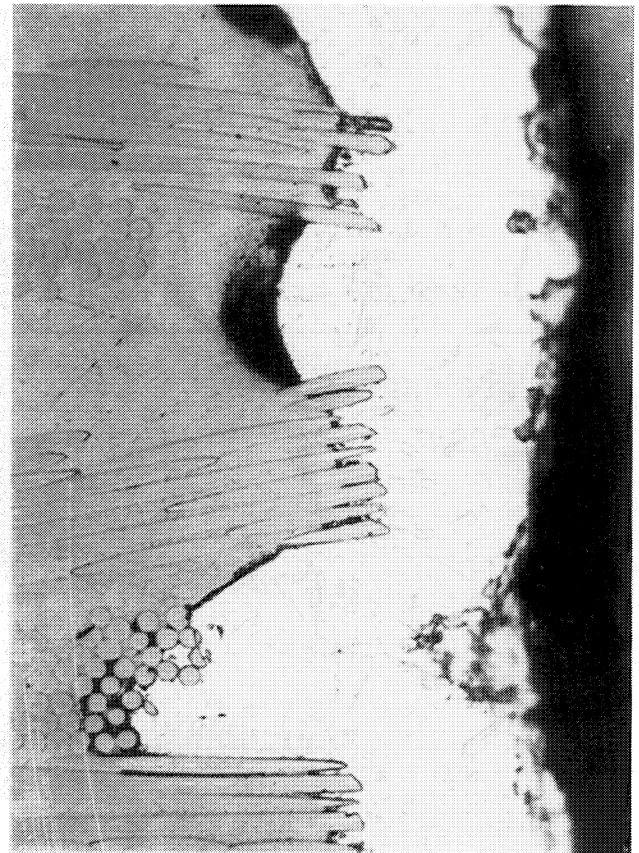
Figure 11 illustrates plating folds. The initial electroless copper plating layer followed and adhered to the irregular surface of the hole wall, and the subsequent buildup of electrolytic copper resulted in a folded structure. These sharp folds have high stress concentration factors, and cracks may initiate at these locations. Coupons exhibiting this condition should be carefully checked for cracked plating after solder float testing. Glass fiber protrusion into brittle and/or thin plating may also lead to cracked barrel plating, Figure 12. Plating folds, nodules, and glass fiber protrusion which project into the hole, Figure 13, are acceptable provided the hole diameter is not reduced below what is specified on the master drawing. Since this drawing is not generally available to the metallographer, the presence of nodules, folds, and protrusion

Figure 11. Plating folds resulting from irregular hole wall surface. Plating in right hand photo has columnar microstructure and should be carefully examined for cracks, particularly after solder float testing. The folds are acceptable. Etched, 400X.

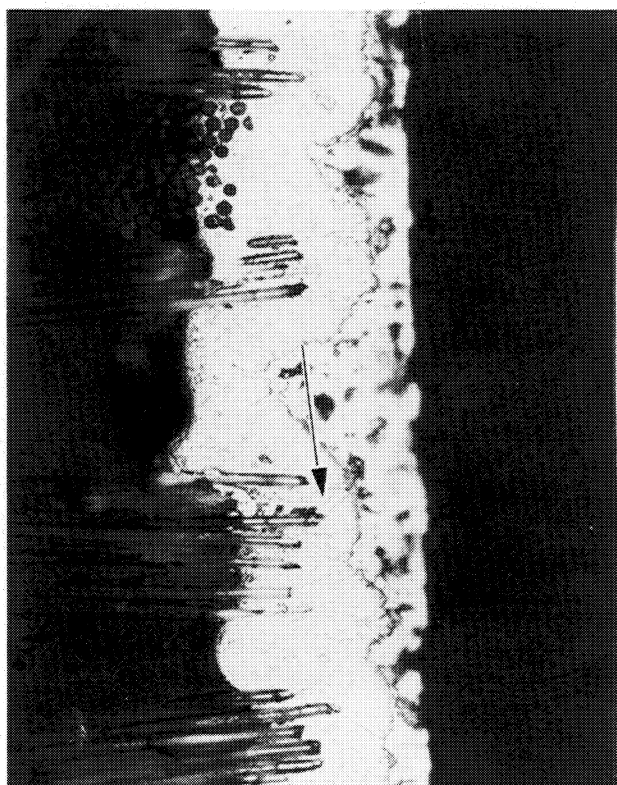
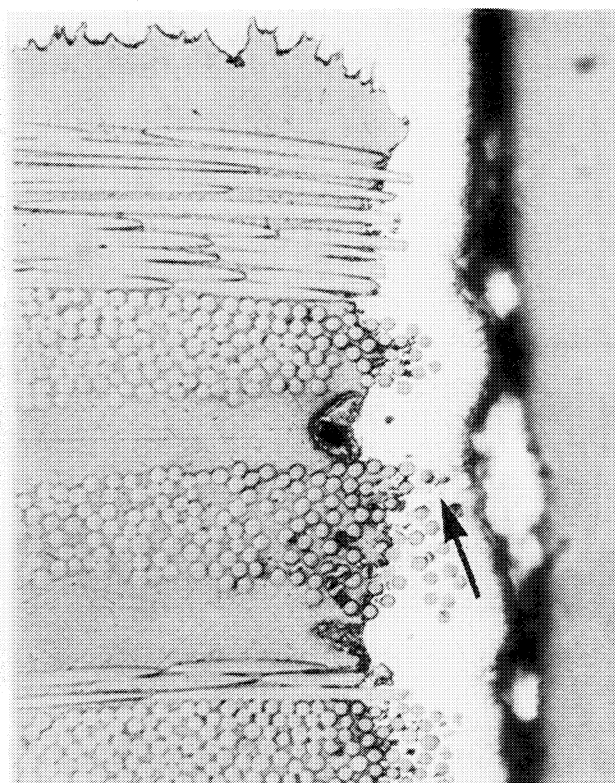
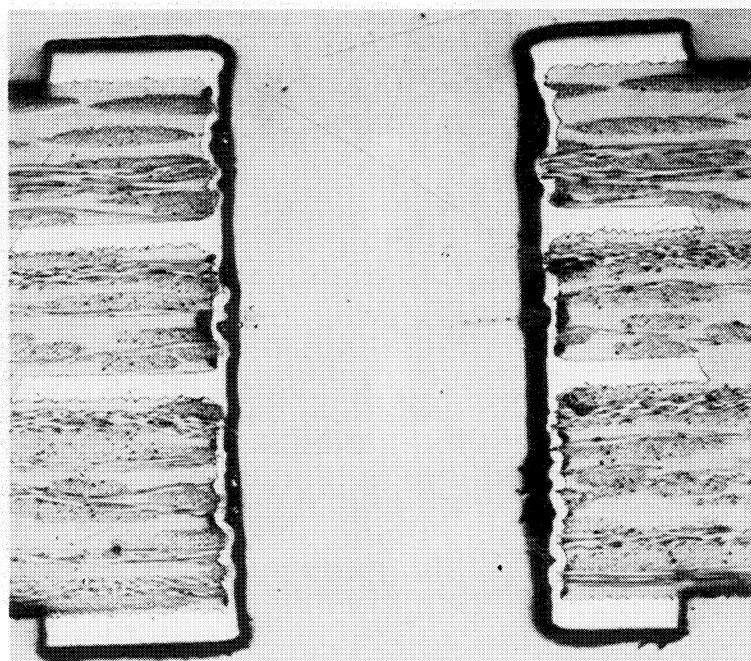
Figure 12. Plated glass fiber protrusion is unacceptable if it reduces the copper plating thickness below the required minimum of 0.001". Cracks have also formed (arrows) in some areas of thin plating.

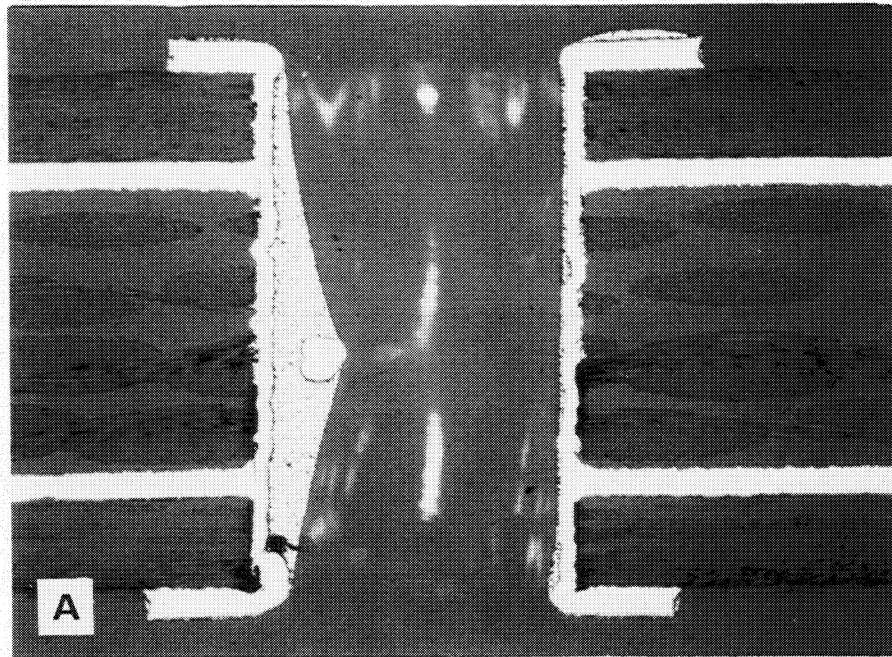
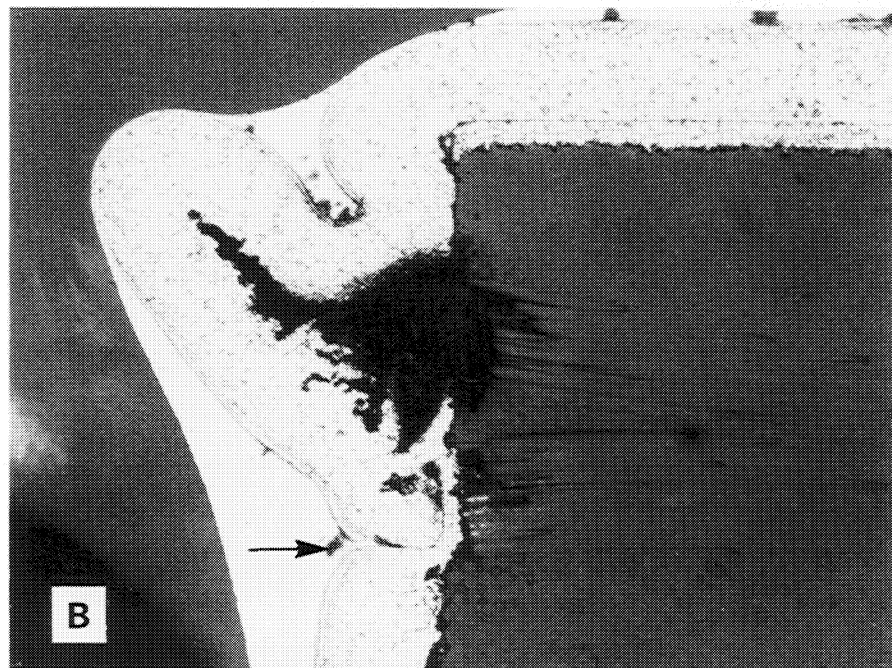
Figure 13. Nodules or plating folds that project into the hole are acceptable if they do not reduce the hole diameter below the minimum required by the master drawing. Note also the plating void. Top — unetched, 50X. Bottom — etched, 200X.

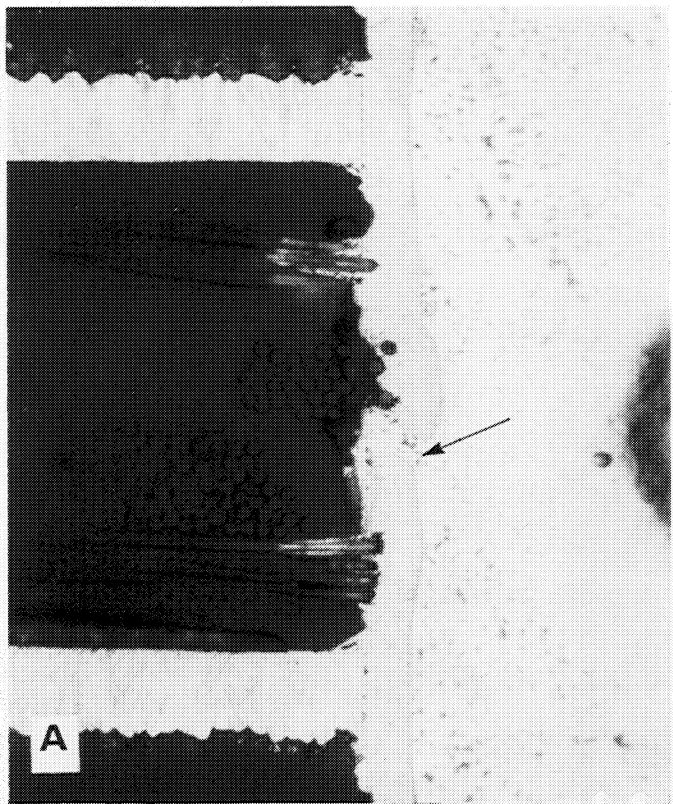
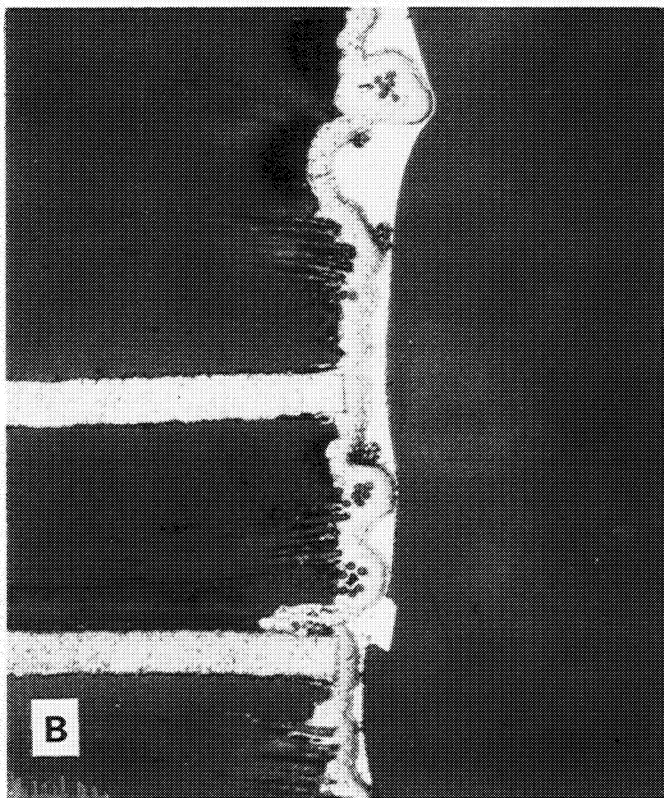
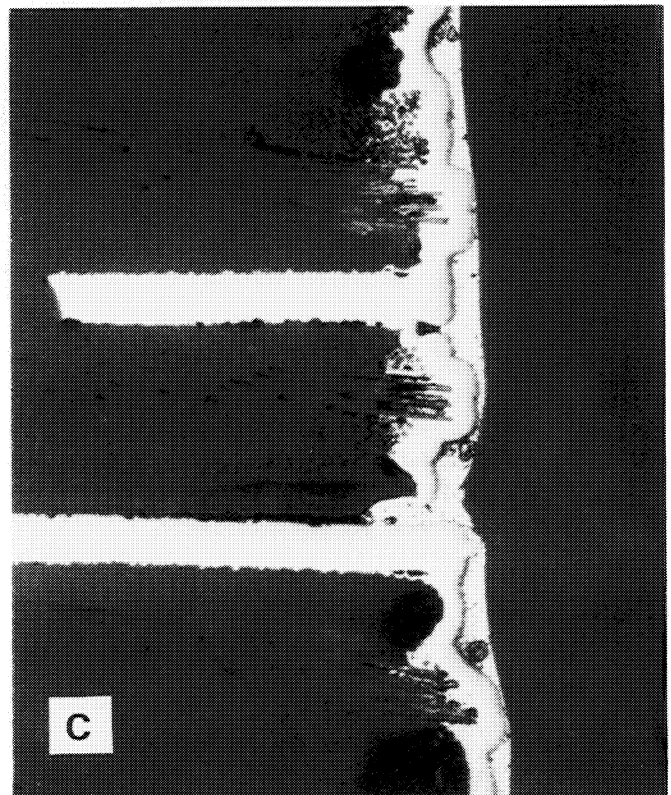
Figure 16. Examples of inadequate barrel plating.

- A. PLATING WHICH IS TOO THIN (IN THIS CASE, 0.0005") CAN CRACK UNDER THERMAL STRESS. ETCHED, 400X
- B. THIN PLATING IF OFTEN ASSOCIATED WITH POORLY DRILLED, RAGGED HOLES, NODULES, AND PLATING VOIDS. ETCHED, 200X.
- C. AS B, BUT UNETCHED.

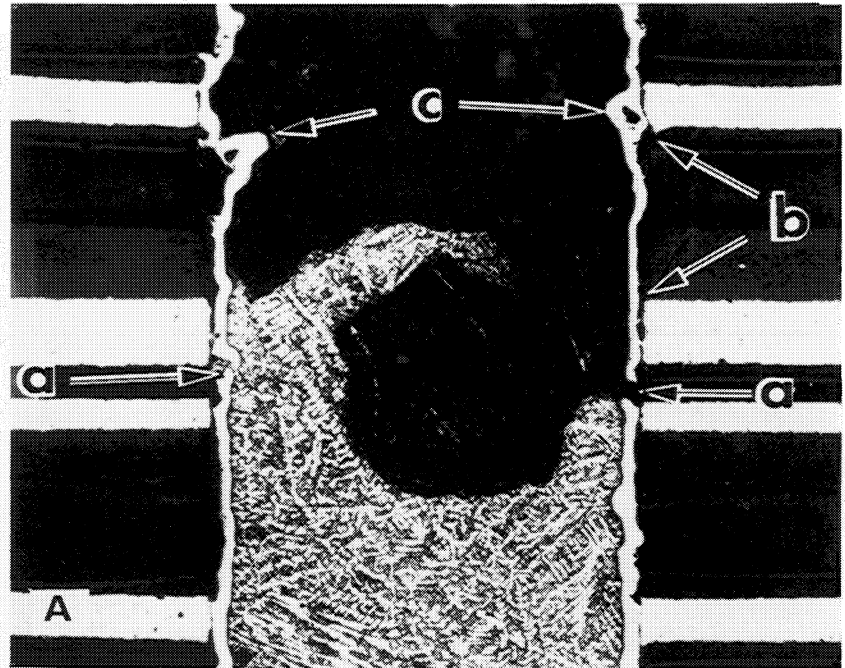
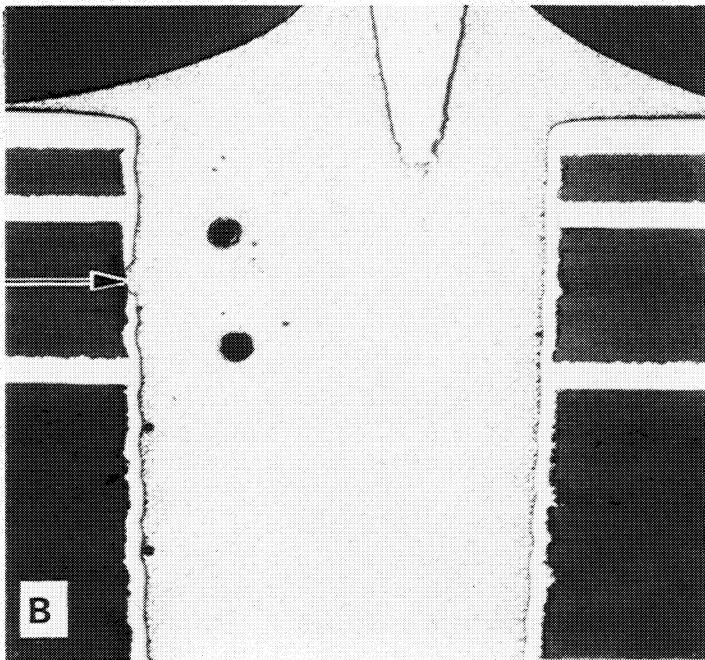
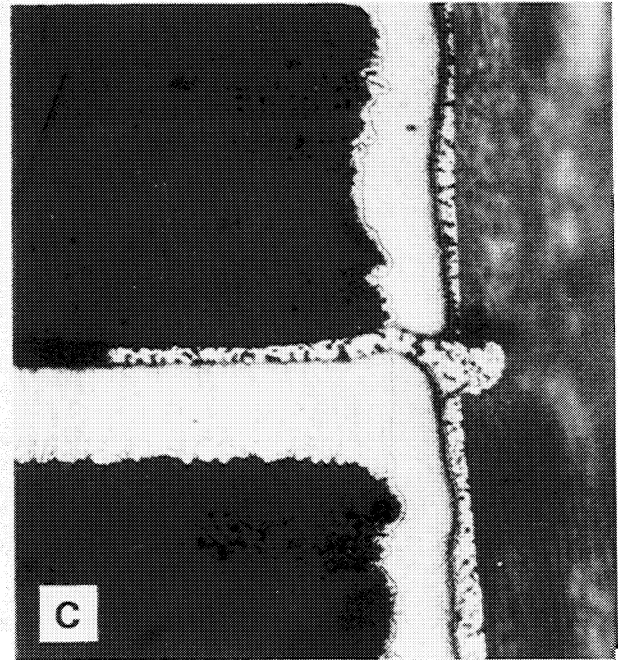
- A. PLATING VOIDS IN THE SAME PLANE (a-a) ARE FORBIDDEN. NOTE ALSO SEPARATIONS (b) AND PLATING NODULES (c). UNETCHED, 80X.
- B. ISOLATED PLATING VOIDS (ARROW) ARE ACCEPTABLE IF NO MORE THAN THREE PRESENT IN ONE HOLE. UNETCHED, 50X.
- C. PLATING VOID RESULTING FROM NON-BRIDGING OF DELAMINATION. SOLDER HAS WICKED INTO DELAMINATION DURING REFLOW. ETCHED, 200X.

Figure 18. Examples of plating voids. The coupon illustrated in A should be rejected for plating voids and separations; that in B is acceptable for plating voids but has rejectable separations; C is rejectable for delaminations.

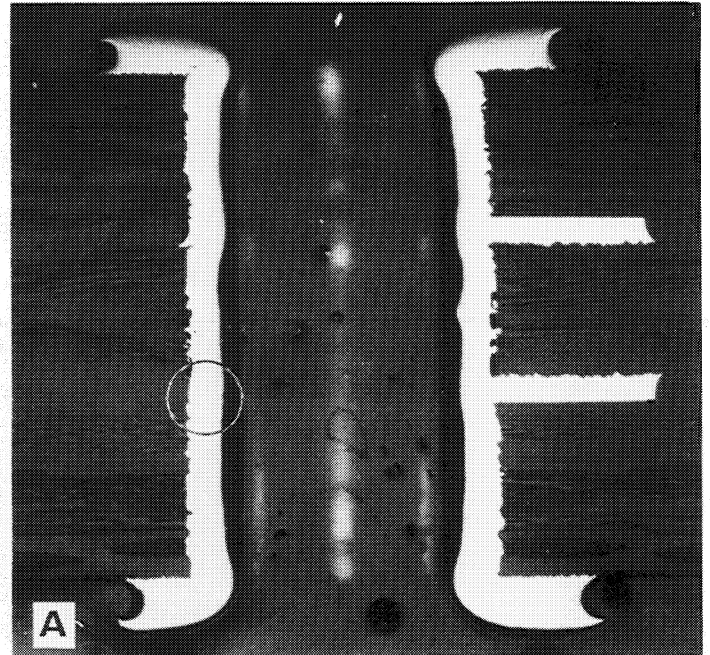
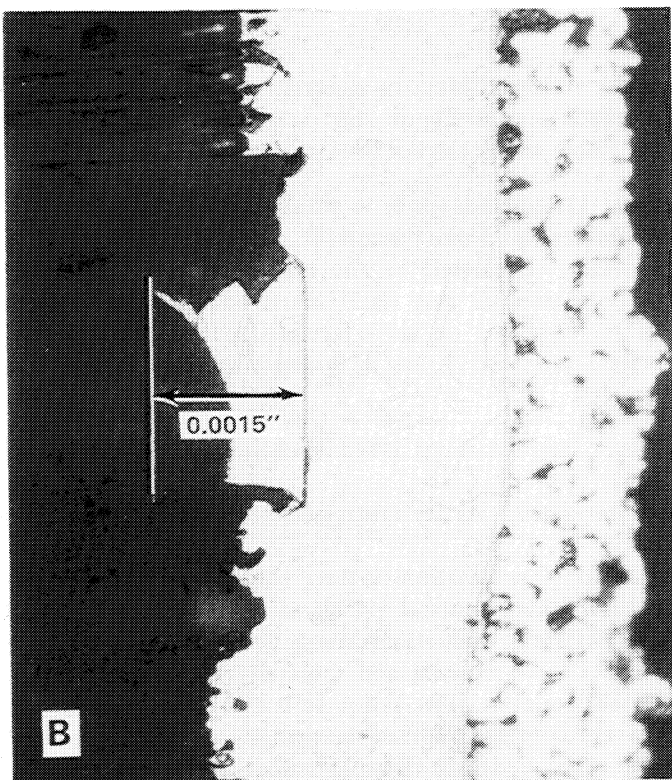
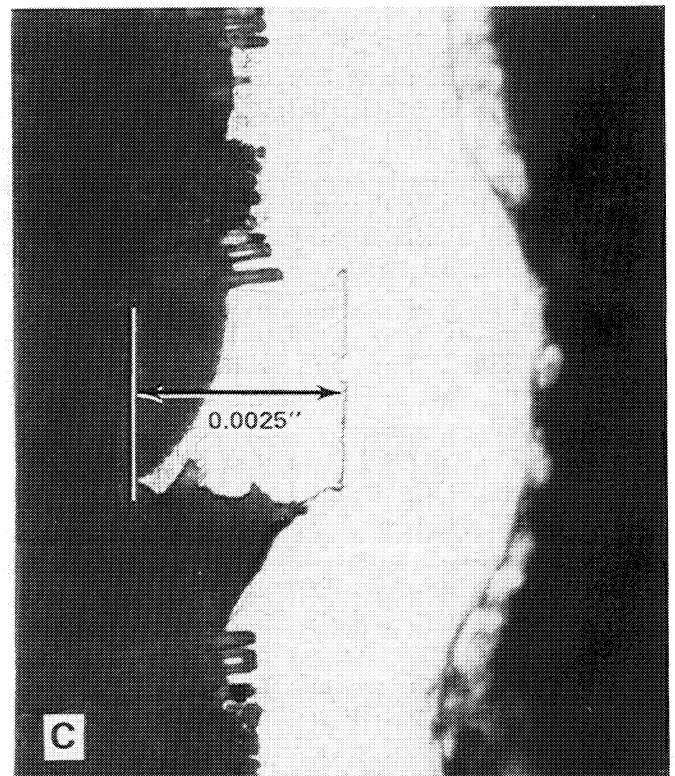
- A. POOR REGISTRATION OF INTERNAL LAYERS HAS RESULTED IN ALMOST NO ANNULAR RING ON ONE SIDE OF THE HOLE. UNETCHED, 50X.
- B. AREA CIRCLED IN A, ETCHED, 500X. ANNULAR RING IS BELOW MINIMUM OF 0.002"
- C. ANNULAR RING BARELY MEETS MINIMUM. ETCHED, 400X.

Figure 23. Internal annular ring should measure 0.002" minimum. Measurement should be made on etched specimen at 100 – 200X.

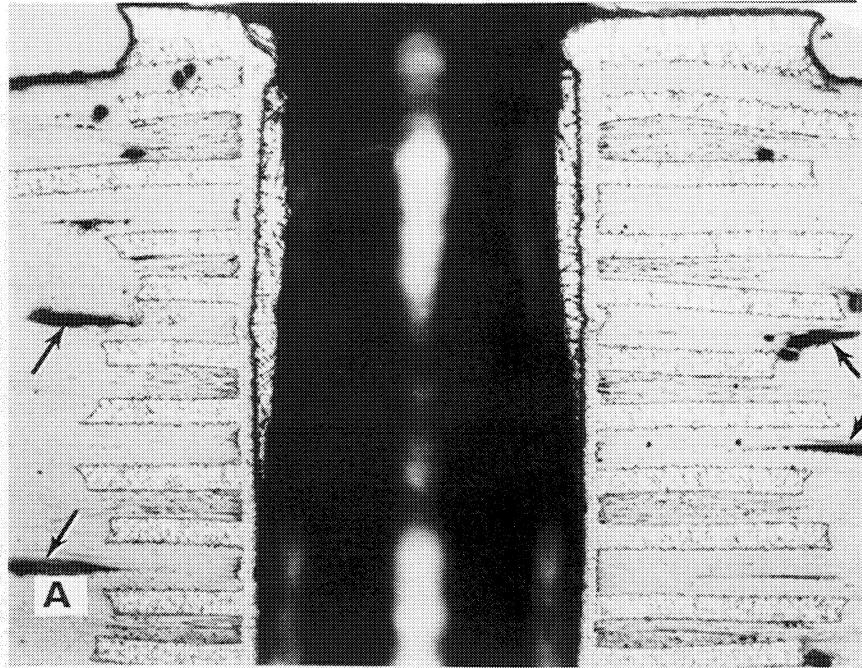
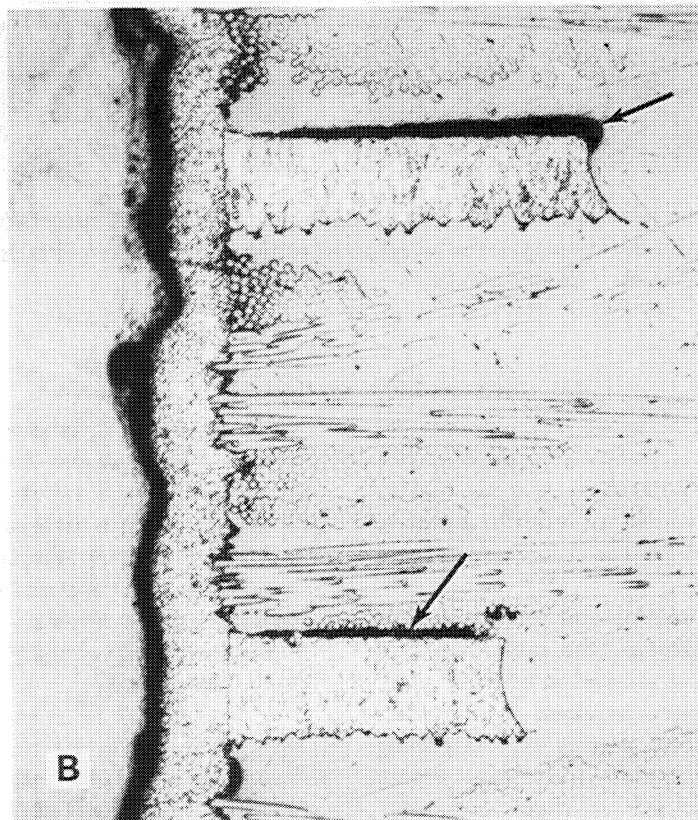
Figure 24. Laminate voids greater than 0.003" are grounds for rejection. Voiding in A is a result of poor laminating procedures. Voids at conductor/laminate interfaces in B are also rejectable in an unstressed (not solder float tested) specimen.

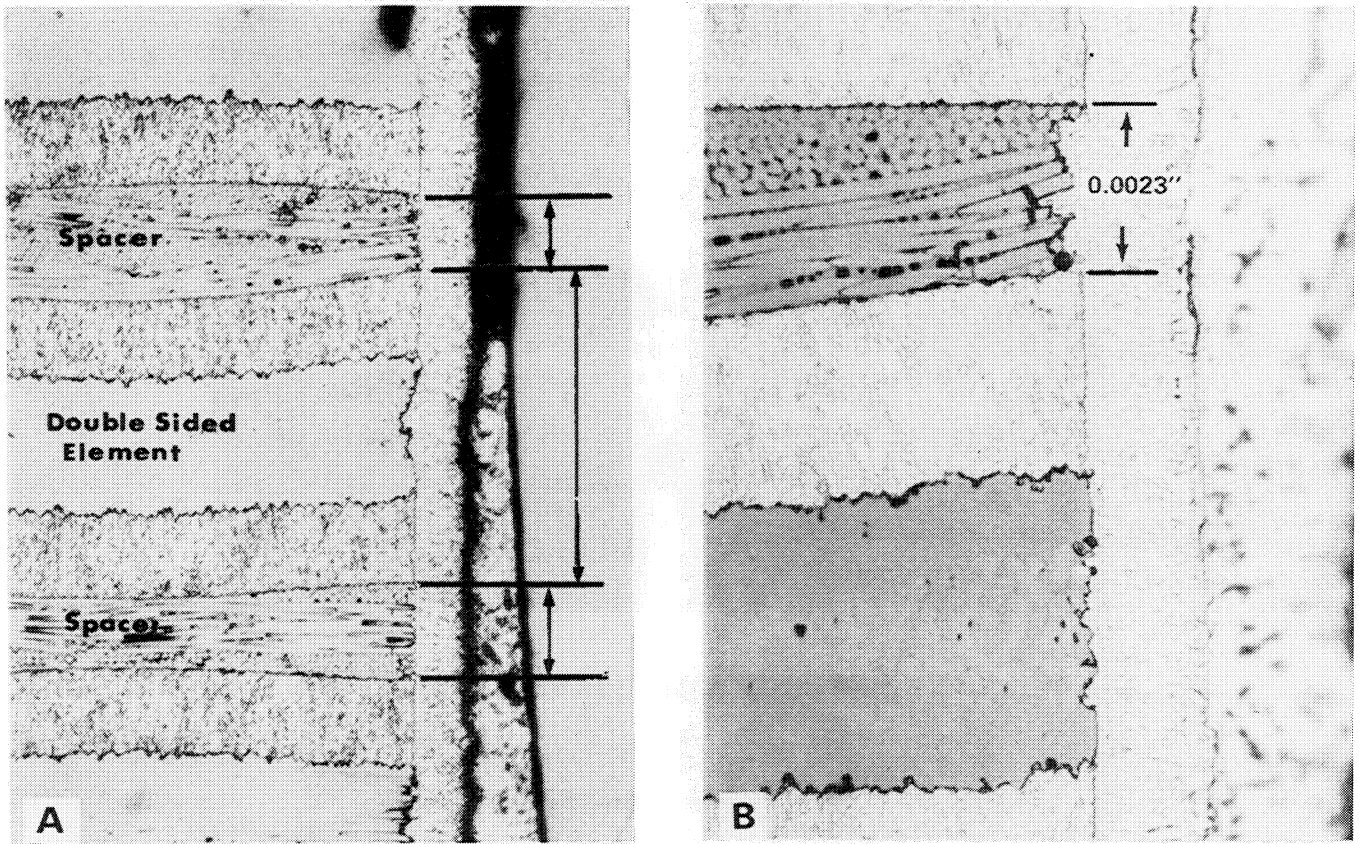
Figure 25. Faulty lamination has squeezed most of the resin out of the B-stage spacers (resin starvation), causing the dielectric thickness between adjacent layers to be reduced below the permissible minimum of 0.0035".
A – Etched, 175X. B – Etched, 400X.

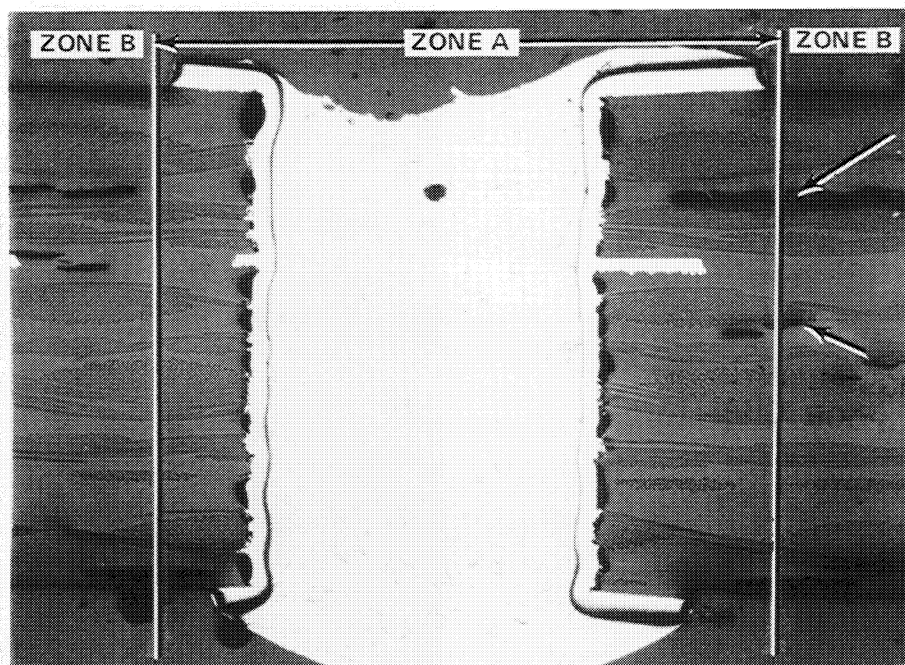
Figure 27. After solder float testing, the laminate is not evaluated in Zone A, that is, resin recession and laminate voids are acceptable in this "thermal zone." Voids in Zone B are evaluated to the same standards set forth for as-received specimens. Voids greater than 0.003" which extend from Zone A into Zone B (arrows) are grounds for rejection. 50 X.

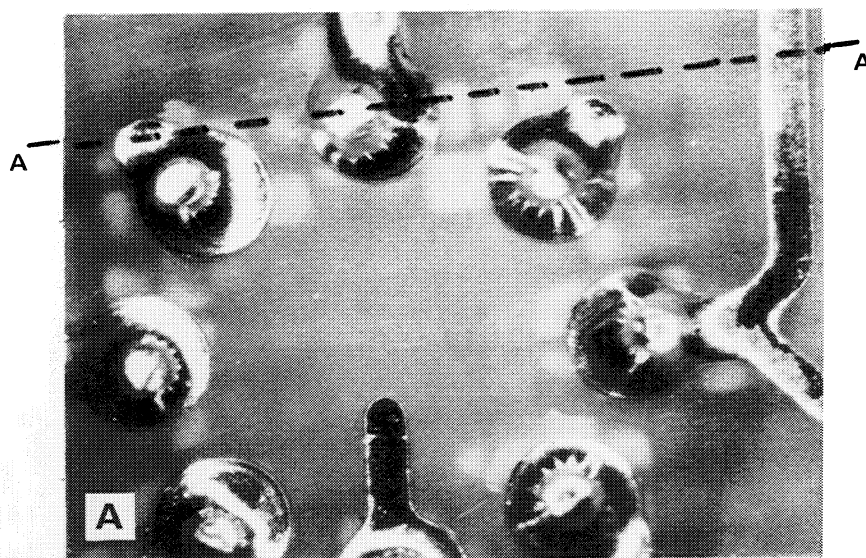
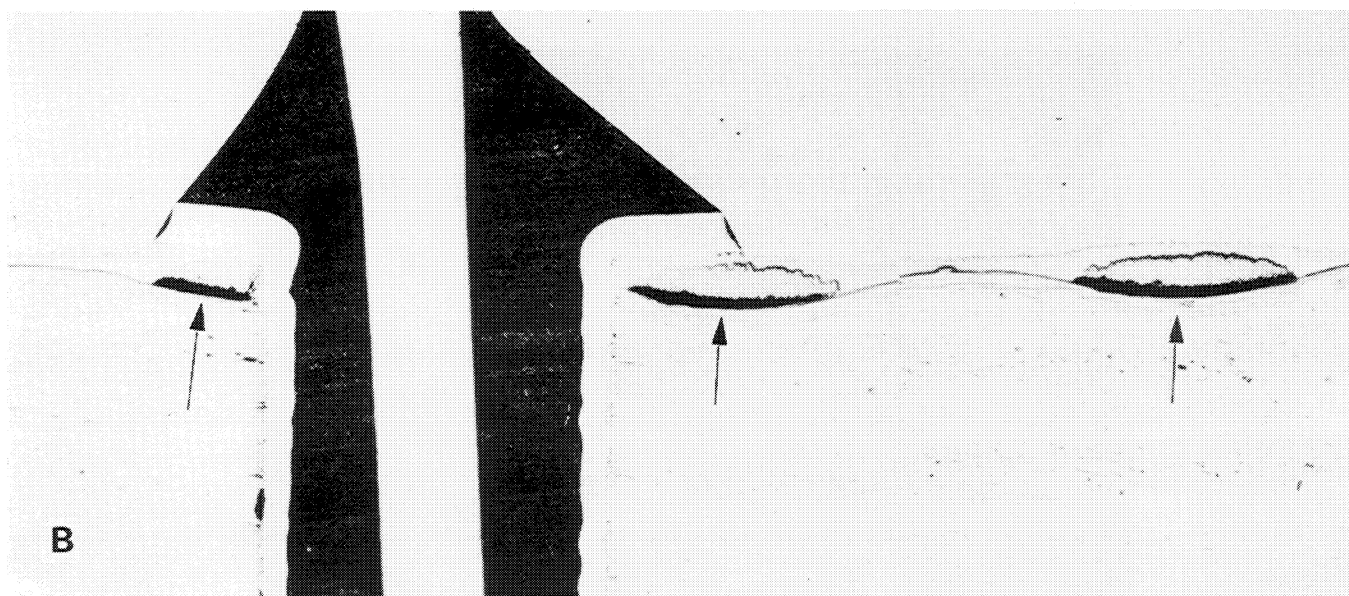
- A. SURFACE OF BOARD SHOWING MEASLES (LIGHT SQUARISH AREAS) WHICH DEVELOPED NEAR SOLDERED HOLES. 10X.
- B. CROSS-SECTION THROUGH A—A ABOVE AT 50X. MEASLES ARE SUBSURFACE SPLITS BETWEEN INTERWOVEN GLASS FIBER BUNDLES. THE SOLDER HAS ETCHED BLACK IN THIS PHOTOGRAPH.

Figure 29. Measles which bridge more than 25% of the space between adjacent conductors or cover more than 1% of the board surface area are not permitted.
